University of California, Irvine
Independent Accident Investigation

*Injury and Fire Resulting From
Benzene Vapor Explosion in a Chemistry Laboratory
Frederick Reines Hall,
University of California, Irvine
July 23, 2001*

FINAL REPORT
January 24, 2002

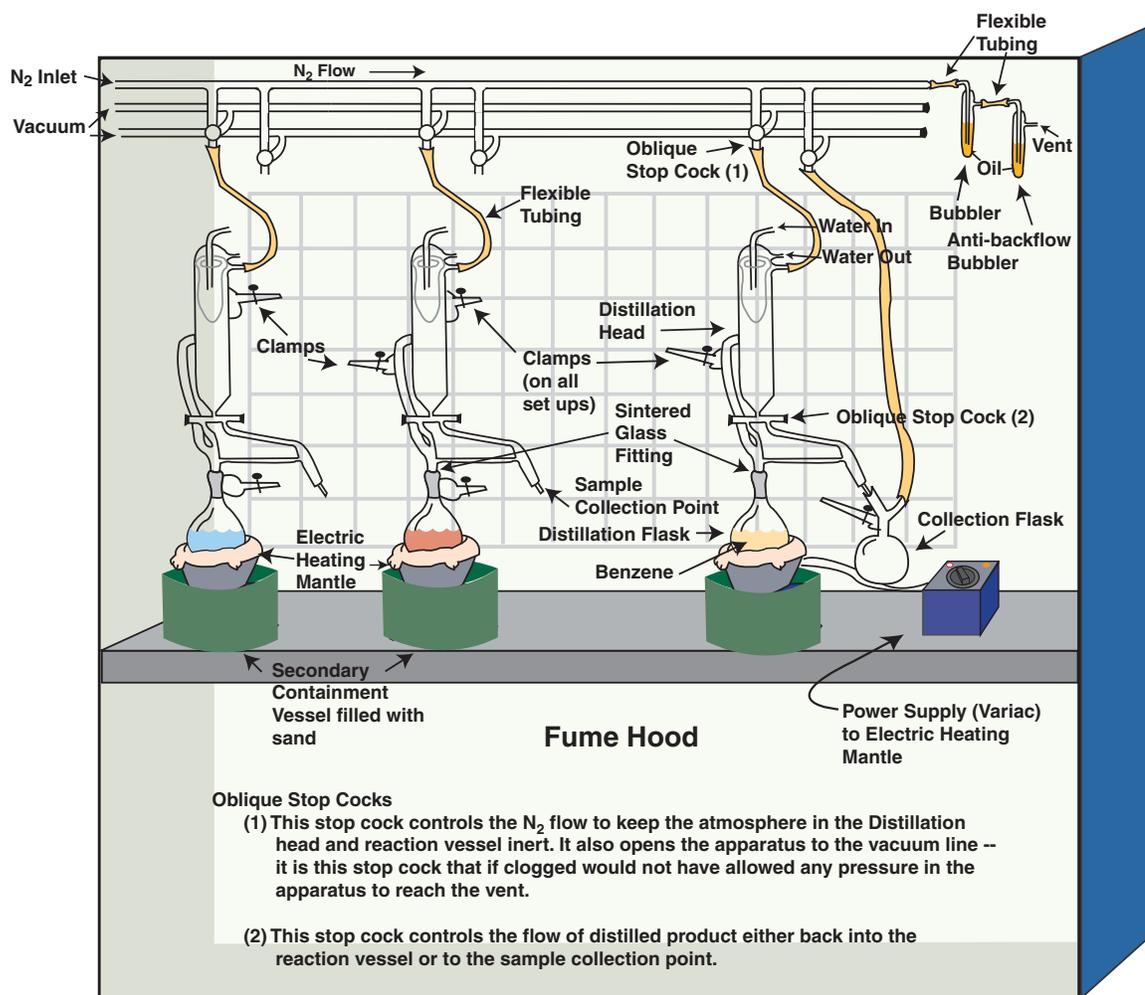
Diagram of Reflux/Distillation Process

The direct cause of the accident was the reflux/distillation apparatus becoming over-pressurized. The over-pressurization caused the system to disassemble at the sintered glass fitting between the two major components of the distillation apparatus. This disassembly resulted in a fine mist of benzene being released into the fume hood, where an unknown ignition source ignited the benzene vapor; resulting in an explosion and subsequent fire.

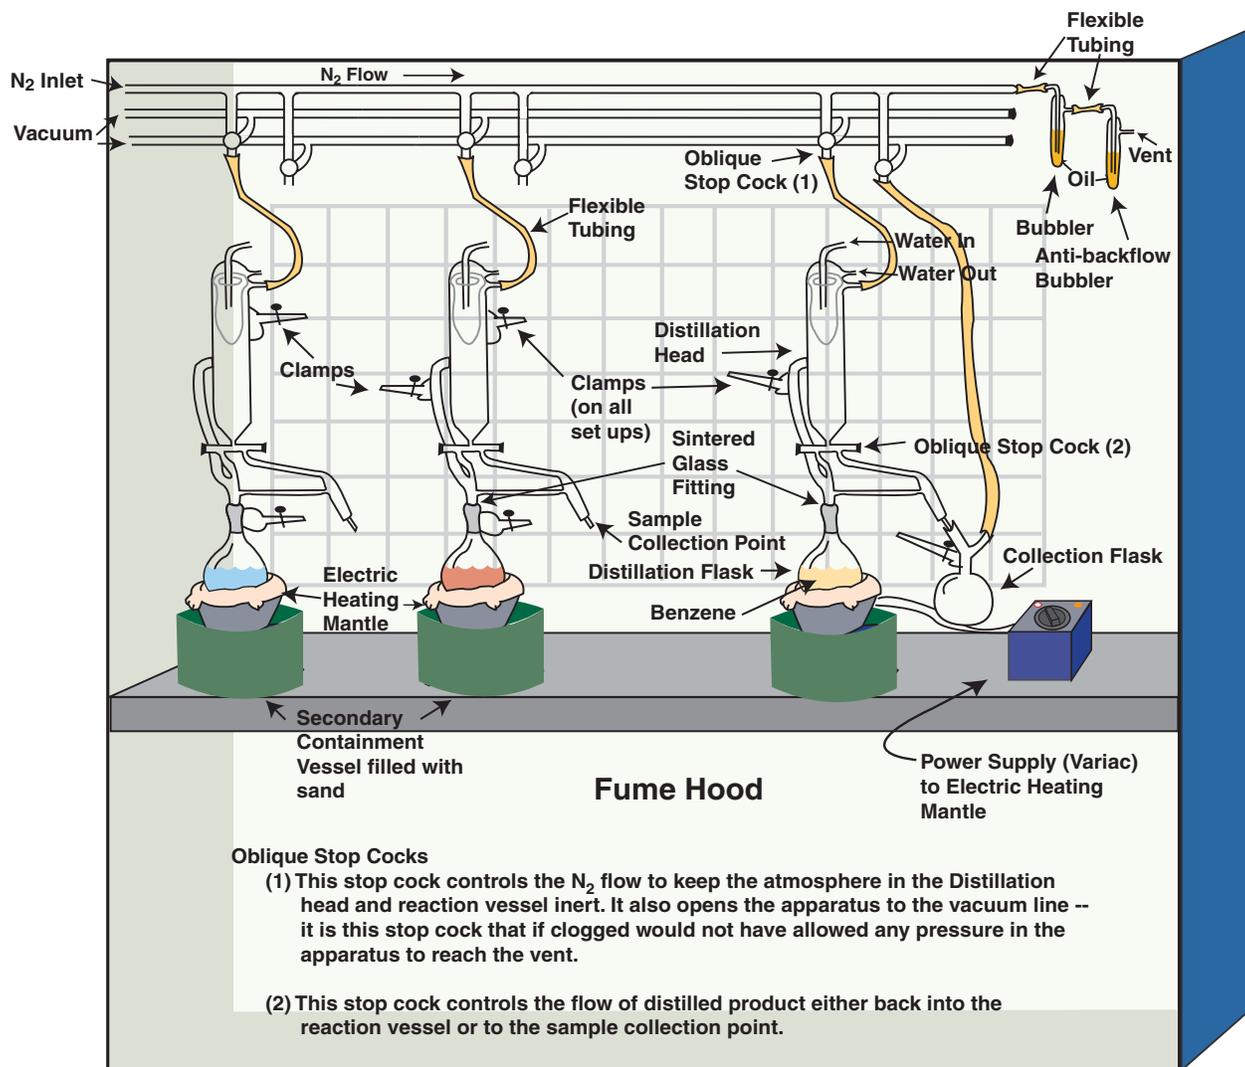
Diagram of Reflux/Distillation Process

Drawing of a fume hood showing the location/identification of critical components of the distillation/reflux apparatus and walk-in fume hood configuration.

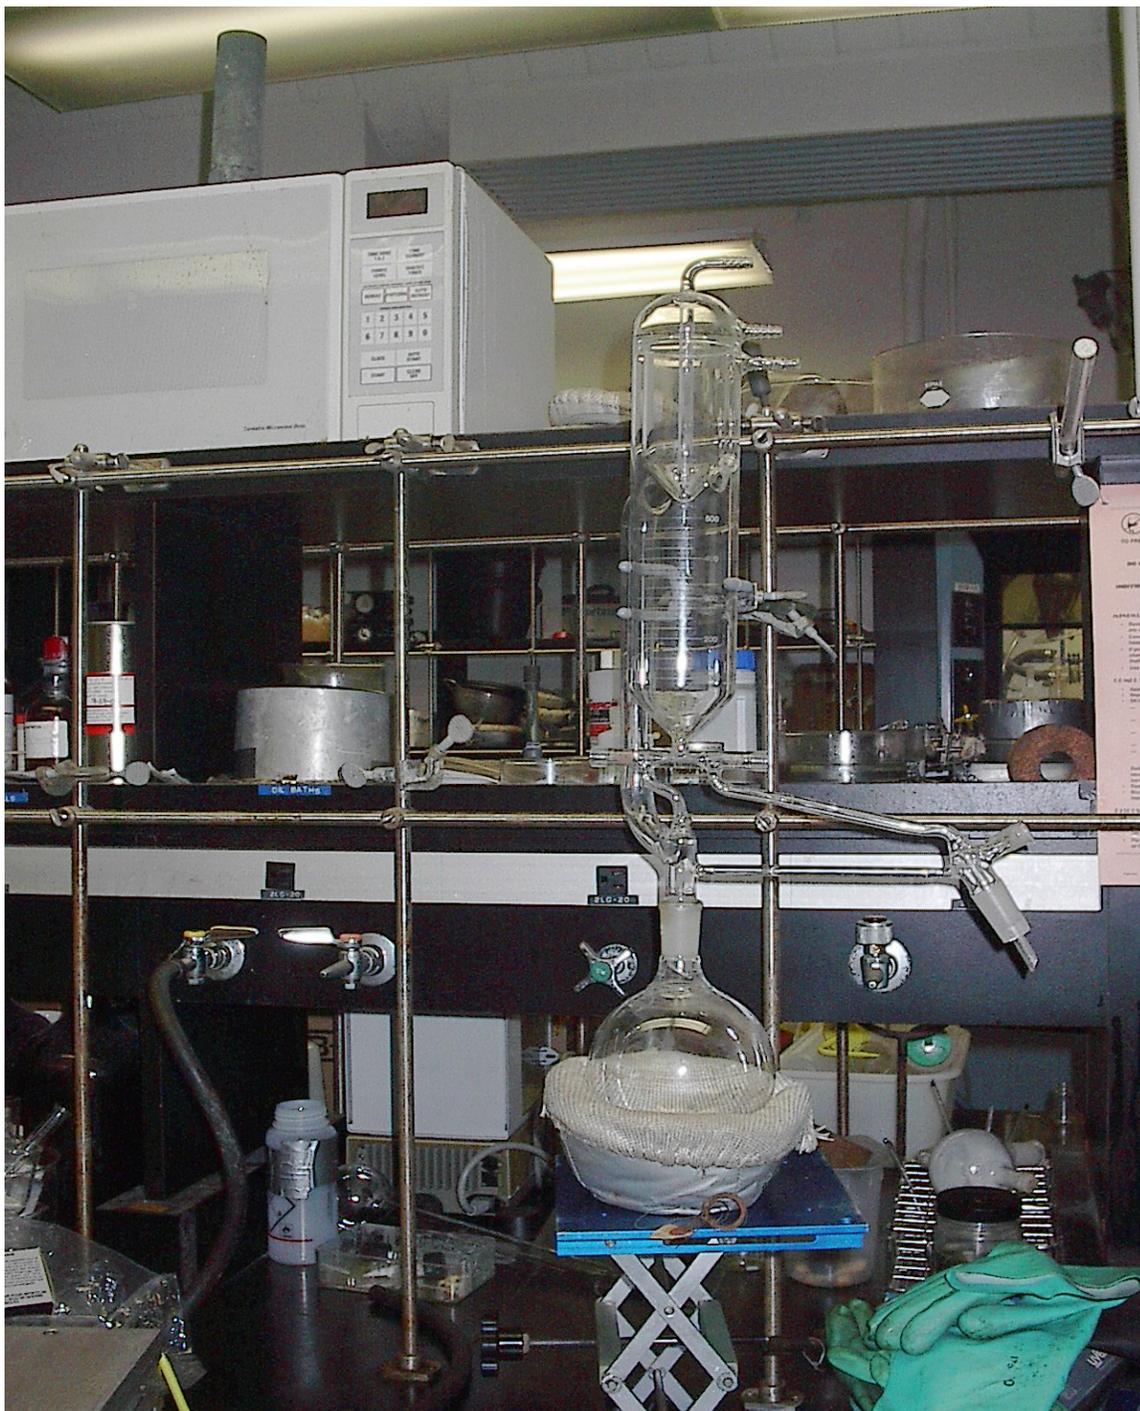
Photograph of the distillation/reflux apparatus that was involved in the incident in Reines Hall on July 23, 2001. This photograph shows the glassware used and was constructed by Dr. Evans to assist the Investigation Team visualize the set-up involved in the incident.
