Lessons Learned—Fluoride Exposure and Response

Benjamin W. Juba, Curtis D. Mowry, Raymond S. Fuentes, Adam S. Pimentel, and Jessica K. Román-Kustas*

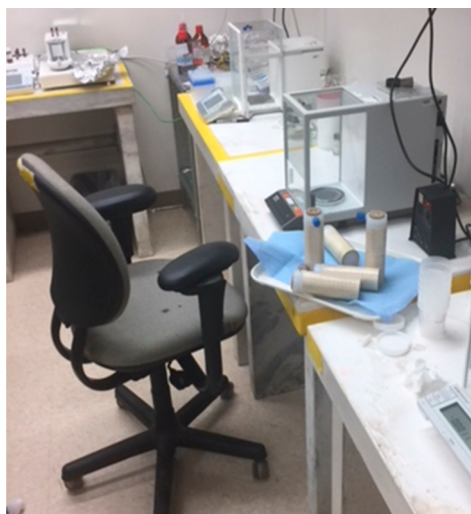
On a late Friday afternoon, a researcher was performing a microwave acid digestion of a refractory metal alloy using an 8% HF solution, made from a combination of 10 mL of HNO₃ (70%) and 2 mL of HF (48%). During the workup of digested replicates, the researcher was in a seated position while at a scale transferring, diluting, and weighing the finished samples. The samples were in digestion vessels, loosely capped, on an unsecured tray. While transferring, one of the top-heavy, unsecured microwave vessels containing concentrated HNO₃ and HF was knocked over, causing a chain reaction resulting in 4 vessels (48 mL of 8% HF/58% HNO₃) spilling and landing in the lap of the researcher (Figure 1). The sitting researcher, who

Figure 1. Post-incident photo of the spill area. Unsecured vessels were transferred using an insufficient secondary containment (similar to a lunch tray) which was incapable of containing a spill. Discoloration on the chair is due to acid damage.

- The “secondary container” meant to prevent and contain spills was insufficient for this task, providing no support to prevent vessels from tipping and insufficient volume to hold spills. This issue was compounded by the risk of the microwave digestion vessels themselves, which when outside of their cartridges, as in this case, did not provide any type of seal.

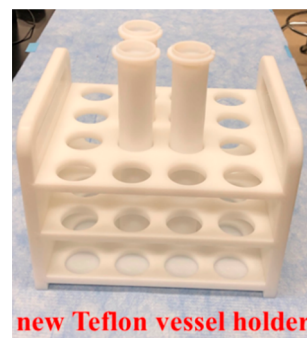
Figure 2. Specially designed Teflon microwave vessel holder. The weight and shape of the holder decrease tipping hazards.

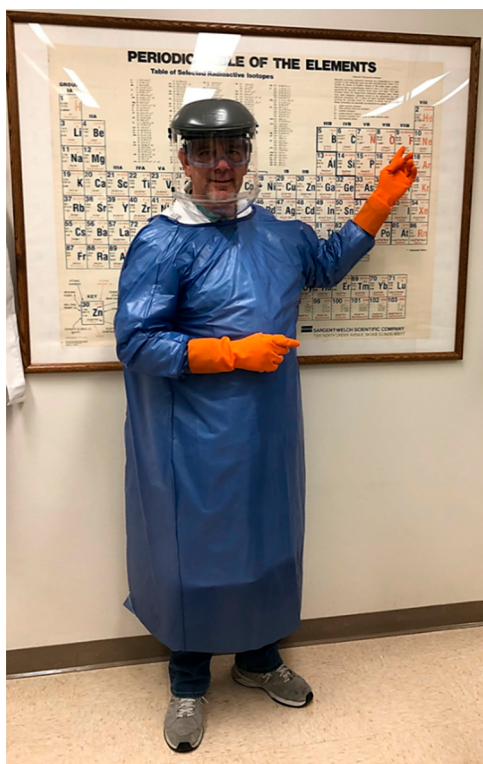
Figure 3. Demonstration of essential PPE required for protection from HF spills. These include close-toed shoes, long pants, vapor protecting chemical splash goggles, plastic apron with full-length sleeves and upper chest protection, face shield with chin splash protection, and nitrile gloves under HF-resistant gloves (Trionic O-240).

- PPE was reviewed and improved, and researchers were trained in the correct use of multilayered protection (Figure 3). Improvements to the PPE included replacing older acid gloves with new Trionic O-240 long-cuffed chemical gloves, chosen due to the glove’s high break-through times (390 min) specifically for concentrated HF and acid solutions.¹⁵ Note: Trionic gloves should only be used once and should be sealed until the time of use, as long exposure to air will degrade the gloves, allowing the potential for pin-hole formation.
