## Earthquake Damage to Labs

Laboratories are particularly dangerous places to be in a significant earthquake. Also, they often contain expensive and/or home-made equipment which would be difficult to replace. Below are some pictures of quake damage that illustrate some seismic preparedness issues:

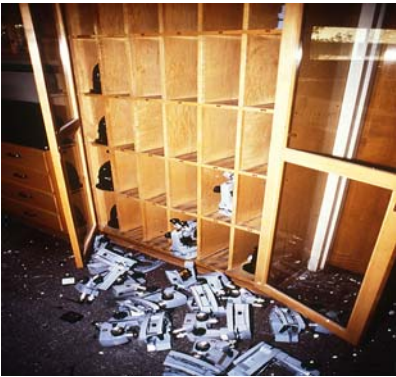
*Cal State Northridge (1994): a latching or locking mechanism on cabinet would have prevented this loss of microscopes.*

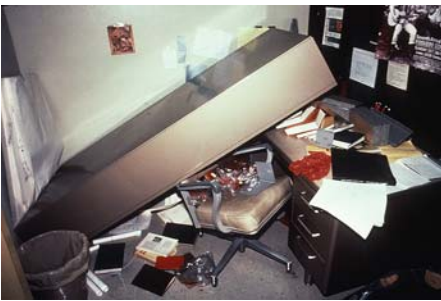
*UCSB (1978): per campus policy, tall furniture and equipment must be anchored securely to solid structural wall elements*

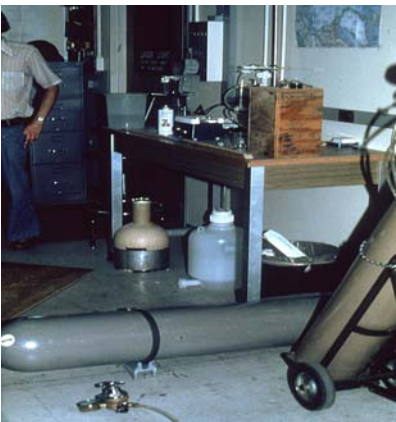
*UCSC (1989): gas cylinder fell to floor shearing off regulator. Fortunately, main valve was closed, thus preventing gas venting. Cylinder was inappropriately anchored to table with “C-clamp” and cloth strap restraint. Per UCSB policy, cylinders must be anchored to solid structural portion of wall with metal chain.*

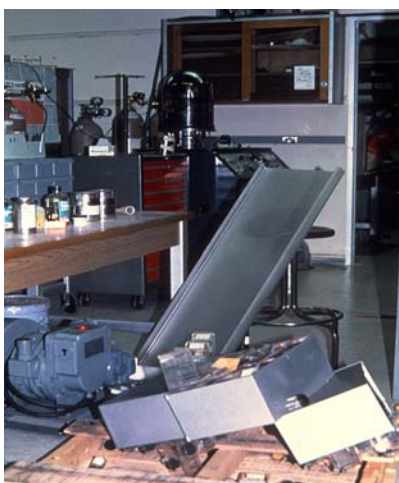
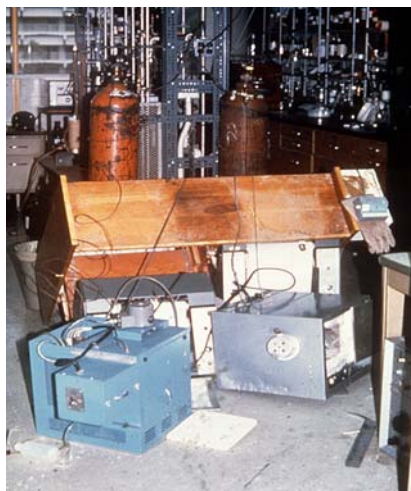
*UCSC (1989): unsecured equipment fell to floor.*

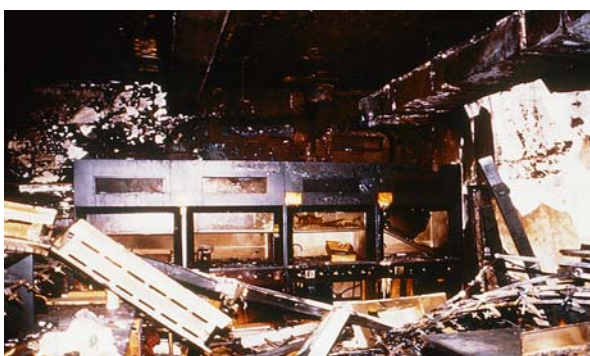
*Cal State North Ridge (1994): lab gutted by fire after quake – note fume hoods on back wall. Mixing of incompatible chemicals caused fire. This may have been prevented by proper segregation of incompatibles.*
